## Impact of dowel bar number and location on pavement performance in a low volume road

Impact of dowel bar number and location on pavement performance in a low volume road

Major: Civil Engineering (Geotechnical Engineering) and (Civil Engineering Materials)

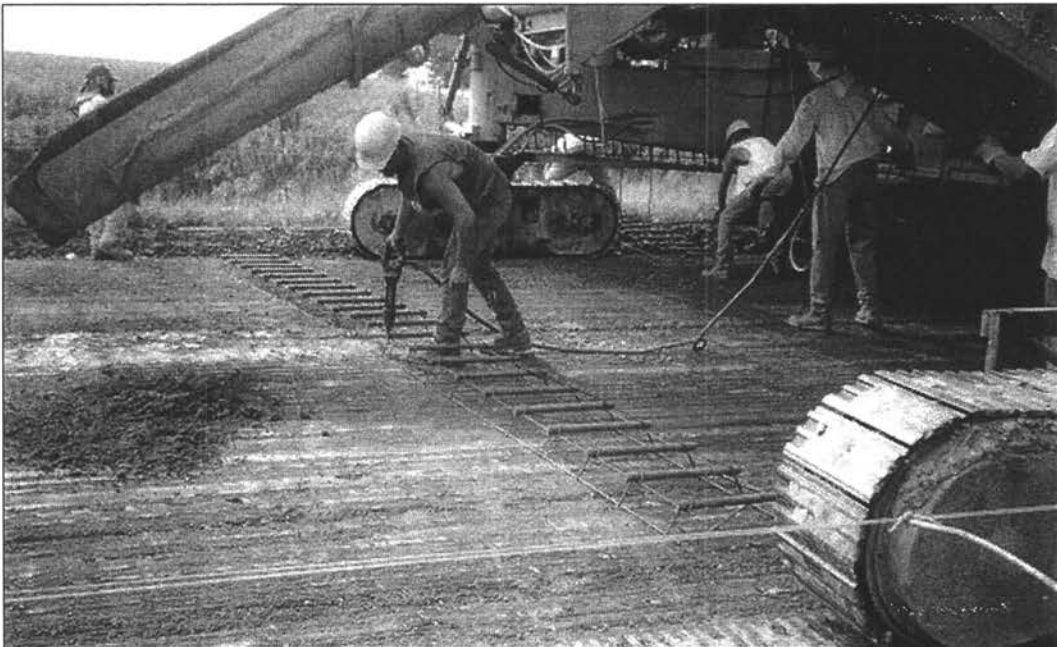
**Figure 3.3 Installation of dowel basket assemblies (Rural site).**

of the paving area prior to the placement of the pavement. As the trimmer passed the intended assembly location the dowel basket assembly was moved into proper alignment. As previously stated, skewed joints were used in the pavement. Therefore, the dowel basket assemblies were also skewed (6:1) with the dowels aligned longitudinally in the pavement (see Figure 3.2). After the dowel baskets were moved into place, they were nailed into the subgrade (Figure 3.3)

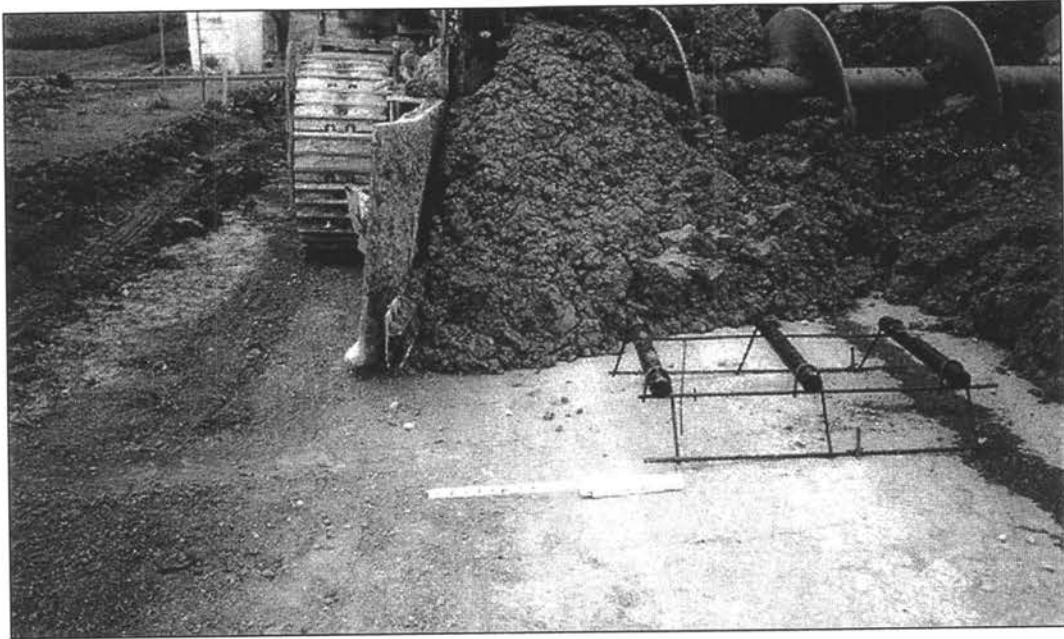
**Figure 3.4 Placement of dowel basket assemblies (Urban site).**

The installation of the partial basket assemblies (three or four dowels) followed the same procedure as that for the full basket assemblies (Figure 3.4). A transverse string line was used to align the smaller assemblies in the longitudinal direction. Figure 3.5 shows a cross-sectional view of a dowel basket assembly in pavement. It should be noted that it was more difficult to secure the basket assemblies to the bituminous base (Urban site) than to the compacted soil base (Rural site).

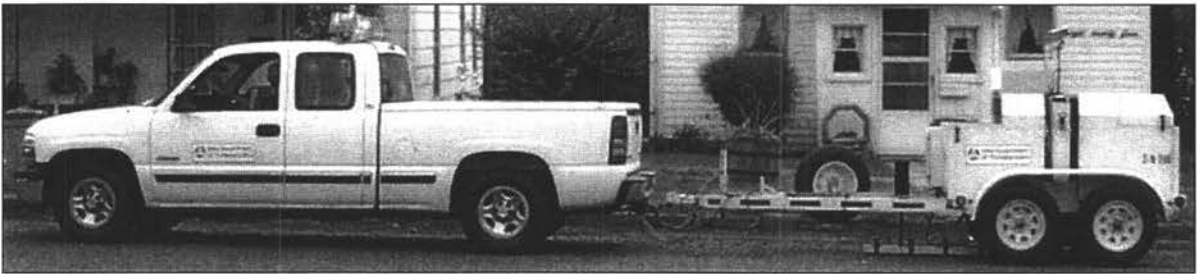
**Figure 3.8 Photograph of a Road Rater and towing vehicle.**

A force setting of 30 Hz and mass displacement of 0.068 inches are recommended for a rigid pavement, which produces a peak-to-peak force of 2,000 pounds [17].

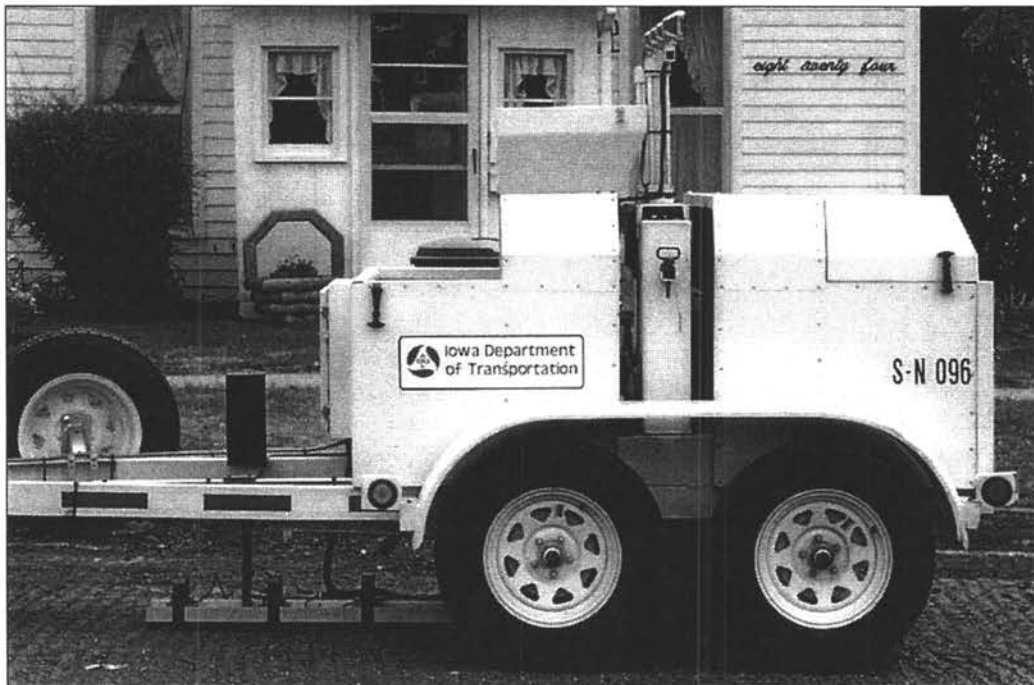
**Figure 3.9 Photograph of a Road Rater.**

The Road Rater is a trailer-mounted machine (Figure 3.8, Figure 3.9) that uses non-destructive testing methods to measure the response of a pavement section to a dynamic load similar in magnitude to that produced by a moving vehicle tire load. A load is hydraulically lowered to the pavement and oscillated to produce a loading force [17].

For photos and a schematic of the Road Rater used for this research project refer to Figure 3.8, Figure 3.9, Figure 3.10, and Figure 3.11 (section 3.4.4).

The deflection of the pavement due to the applied load is measured by four velocity sensors and collected by a computer in the tow vehicle. One velocity sensor is positioned directly beneath the load; the other three sensors are positioned at one-foot intervals. The deflection of the pavement is illustrated in Figure 3.10 and the Road Rater schematic is illustrated in Figure 3.11.
